Novelli, V., Ngoma, I., Kloukinas, P., Kafodya, I., De Risi, R., Macdonald, J., & Goda, K. (2019). *Seismic Vulnerability Assessment of Non-engineered Masonry Buildings in Malawi*. Paper presented at 7th International Conference on Computational Methods in Structural Dynamics and Earthquake Engineering , Crete, Greece.

SEISMIC VULNERABILITY ASSESSMENT OF NON-ENGINEERED MASONRY BUILDINGS IN MALAWI

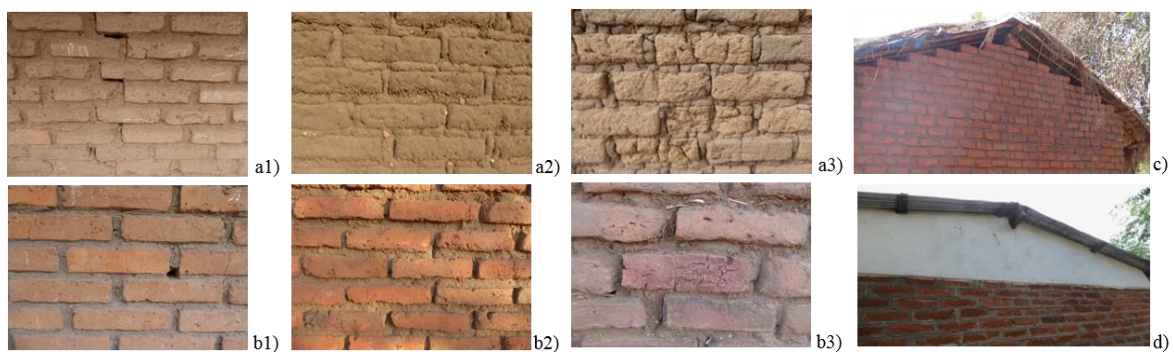
Figure 2: a1) and b1) good; a2) and b2) medium and a3) and b3) poor fabric quality of unfired and fired bricks, respectively c) thrached roof and d) metallic sheet roof

The most common typology observed in Malawi, B, representing 52 % of the buildings, is rated as medium seismic vulnerability (see Figure 3(b)). These buildings were made of fired bricks characterized from poor to a good quality fabric (Figure 2(b1), (b2), and (b3)). Due to the presence of mud mortar in these houses, the bonding between bricks is considered poor, therefore connections between walls were assumed weak. The construction details varied significantly, as well as maintenance levels.

Typology C covers 28% of the inspected houses (see Figure 3(c)). These were made of fired bricks from poor to good quality fabric (Figure 2(b1), (b2), and (b3)) and cement mortar. Generally, these houses had a larger floor plan than the typical plan. Due to the extended plan size, irregularities were likely to occur (e.g. portico and re-entrant corner). Most of these houses had corrugated metallic sheets supported by timber elements or truss, and good structural detailing (e.g. adjacent walls and walls/roof are connected). The good structural quality of these houses can be also attributed to the presence of strengthening elements (e.g. ring beams).

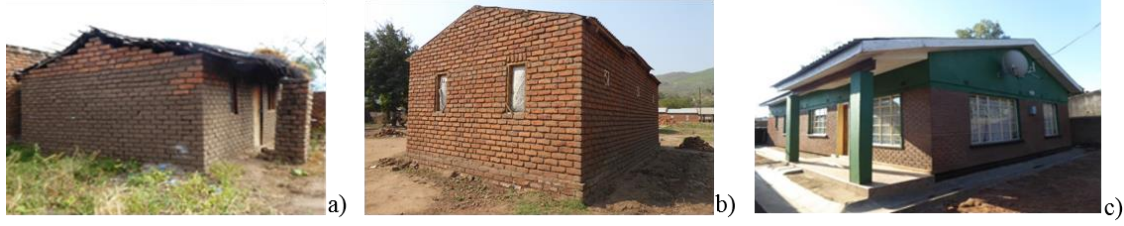
According to the collected data described above, inspected buildings, as illustrated in Table 1, are classified in three typologies: A, B, and C (shown in Figure 3) introduced in the World Housing Encyclopedia by the authors [9, 13] Typology A is representative for 20% of the inspected buildings, characterized by low seismic vulnerability (Figure 3 (a)). These buildings were made of mud mortar combined with fired bricks of poor fabric quality (see Figure 2(b3)) and unfired bricks from poor to high fabric quality (see Figure 2(a1), (a2), and (a3)). Generally, these houses have smaller building footprints than the typical floor plan of 8 m \times 6 m. Most of these houses (17%) have thatch supported by light timber elements, while the remaining are made with metallic sheet roof. Roof structures are characterized by a poor structural detailing (e.g. lack of connection between walls and between the walls and roof).

Figure 3: Typical one-story masonry building in Malawi. a) typology A; b) typology B; c) typology C
